**REPORT ON THE
INVESTIGATION OF SUBSURFACE
PETROLEUM CONTAMINATION
AT THE WATERVILLE GARAGE,
WATERVILLE, VERMONT**

VTDEC SITE #92-1315
GRIFFIN PROJECT #10934451

JUNE 2, 1994

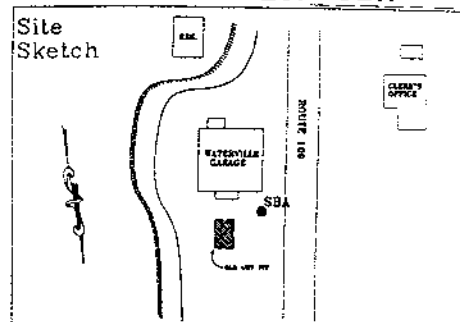
WELL NUMBER SBA

PROJECT WATERVILLE GARAGE
 LOCATION WATERVILLE, VERMONT
 DATE DRILLED 2/16/94 TOTAL DEPTH OF HOLE 29'
 DIAMETER _____
 SCREEN DIA. _____ LENGTH _____ SLOT SIZE _____
 CASING DIA. _____ LENGTH _____ TYPE _____
 DRILLING CO. GMB DRILLING METHOD HSA
 DRILLER LAWRENCE LOG BY M. CASSARA

DEPTH IN FEET	WELL CONSTRUCTION	NOTES	BLOWS PER 6" OF SPOON & PID READINGS	DESCRIPTION/SOIL CLASSIFICATION (COLOR, TEXTURE, STRUCTURES)	DEPTH IN FEET
0		GRADE			0
2					2
4					4
6			5'-7' 100 ppm	Silty fine SAND, little gravel light brown to gray blue	6
8		NATIVE BACKFILL			8
10			10'-12' 34 ppm	Fine brown SAND to gray fine sandy silt, moist	10
12					12
14					14
16			15'-17' 190 ppm	Silty fine SAND, mottled gray moist, strong odor	16
18		BENTONITE			18
20			20'-22' 6 ppm	Light brown fine to medium SAND, dry, little silt	20
22		NATIVE BACKFILL			22
24					24
26			25'-26.5' 2.8 ppm	Silt CLAY lens at 25' above silty fine SAND, moist	26
28					28
30		UNDISTURBED NATIVE MATERIAL		AUGER & SPOON REFUSAL AT 29'	30
32					32
34					34
36					36
38					38
40					40
42					42
44					44
46					46
48					48
50					50
